Visual Distortion Observed in Low-E Tempered Glass

January 27, 2012

The Truth about Tempered Glass

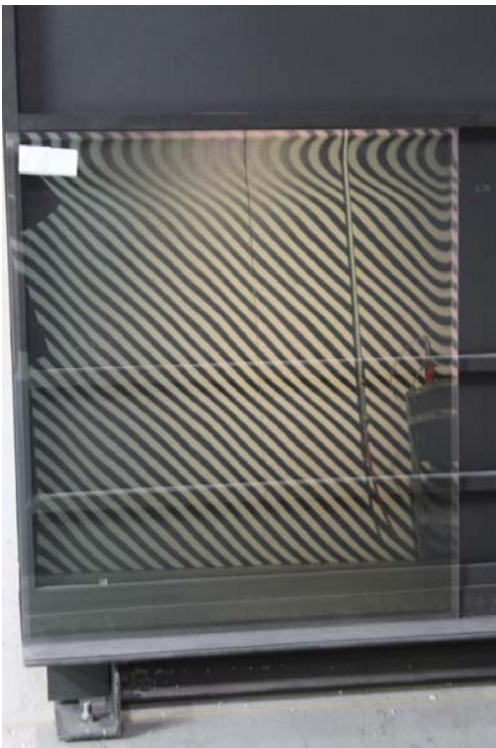
When we began working on the process back in July, the edge curl was on the leading and trailing edge and was measuring between 0.020-0.025" and sometimes had roller wave measuring 0.005". Today the roller wave has been eliminated, the edge curl on the trailing edge is eliminated and the edge curl on the leading edge is under 0.010".

The glass used in the windows in the first house we looked at was from this new process. The windows in the finished house had windows made prior to the changes. These windows had distortion on the top and bottom of each sash. After seeing the distortion in the glass with 0.010" edge curl, it still had a noticeable visible distortion.

1. Viwinco Current 3mm Low-E Tempered Glass

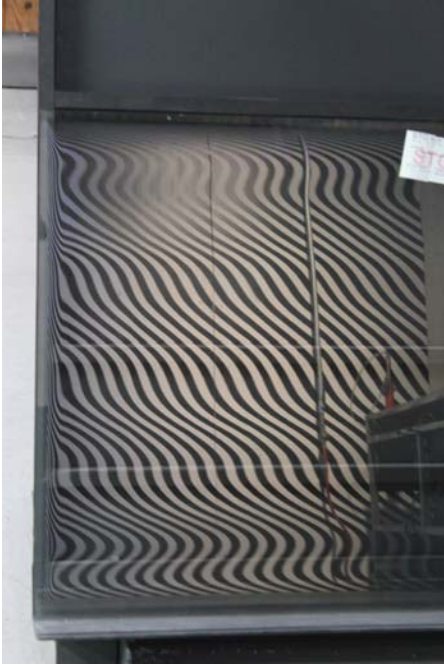
- Use annealed low-e glass for the external glass on DH, SH, Casements, Awnings and Sliders. This option would eliminate the effect of visual distortion. In order to do this we would have to retest all products listed above with annealed glass in the outboard lite.
- The final option is to purchase our low-e tempered glass for OceanView products from an outside source. We bought low-e tempered glass from two different suppliers with the hopes of putting them in an IGU and taking them down to one of the houses we looked at doing a comparison. When the glass came in from both vendors it was far worse than ours was back in July. (Pictures #2 and #3).

2. Vendor #1: 3mm Low-E Tempered Glass 3. Vendor #2: 3mm Low-E Tempered Glass

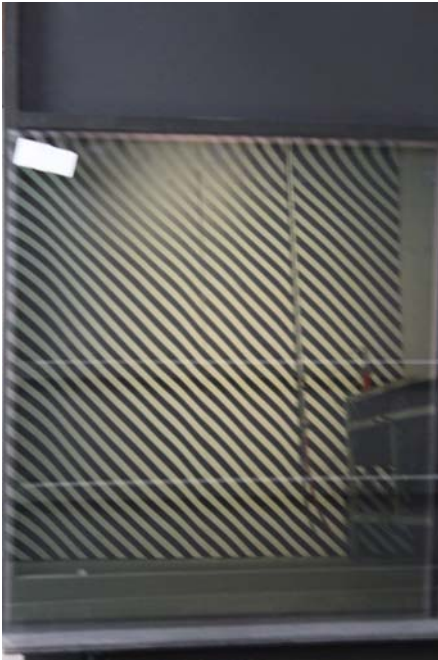
- Make the tempered glass with a heavier tempered lite. By using a thicker glass (4mm or 5mm) instead of the 3.2mm glass that we currently use, we could minimize the edge curl. We made a sash with the 5mm tempered low-e glass and sent it down with Michael to install and review. Even though the edge curl was minimized the distortion was still slightly visible. We are going to continue to refine the recipe for the 5mm glass. We ordered 4mm glass to test and should be making samples the week of 1/23/12. There is a picture showing the 5mm glass further down (Picture #4).

4. Viwinco 5mm Low-E Tempered Glass 5. Viwinco 5mm Annealed Glass
