Visual Distortion Observed in Low-E Tempered Glass

January 27, 2012

The Truth about Tempered Glass

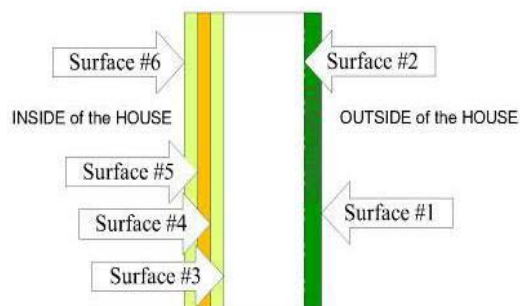
- Moving the low-e coating from surface 2 to surface 3 in the IGU. The visual distortion is an effect of having the low-e coating which is highly reflective on a tempered glass that is not flat. The light being reflected and refracted at different angles and speed on an uneven surface is what causes the distortion. We evaluated the possibility of moving the low-e coating from the number 2 surface (the inside surface of the exterior lite) to surface 3 (the inside surface of the inside lite). (Example below.) Even though this would eliminate the issue it would have a negative effect on the NFRC and Energy Star thermal numbers. Because of tighter thermal requirements, this is not an option.
